**NPDES
Inspection Report**

**Majestic Farms
(NPDES Permit #: Unpermitted)**

Inspection Date: April 25, 2017

**Joe Roberto
Environmental Protection Agency, Region 10
Office of Compliance and Enforcement
Multimedia Inspection and RCRA Enforcement Unit**

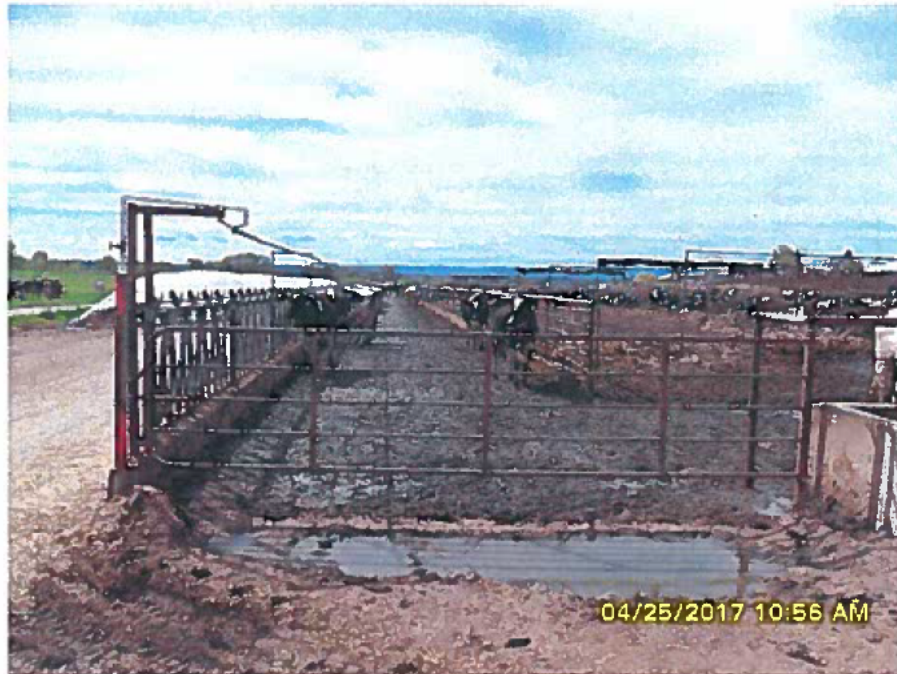
Photo #1: Southerly view of the feed bunk area of an open cow confinement lot. This photograph was taken of the northeast corner of the facility. Camera photograph #SAM 2734.

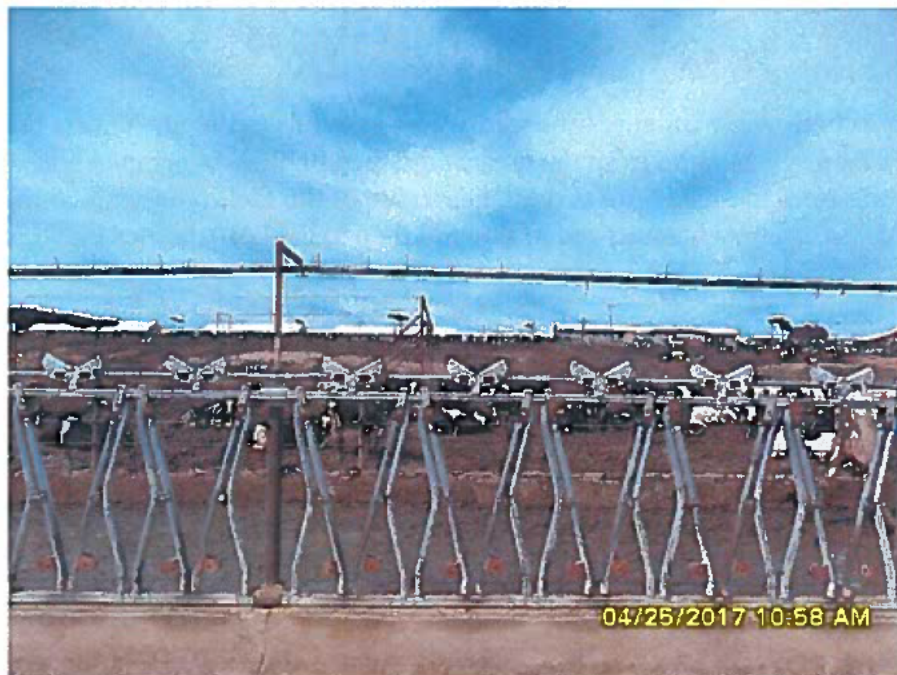
Photo #2: Westerly view of an open cow confinement lot. Note the feed bunk in the foreground and the dirt lot in the near background. Also note the milk house in the right background. Photograph was taken along the east side of the confinement area of the facility. Camera photograph #SAM 2735.

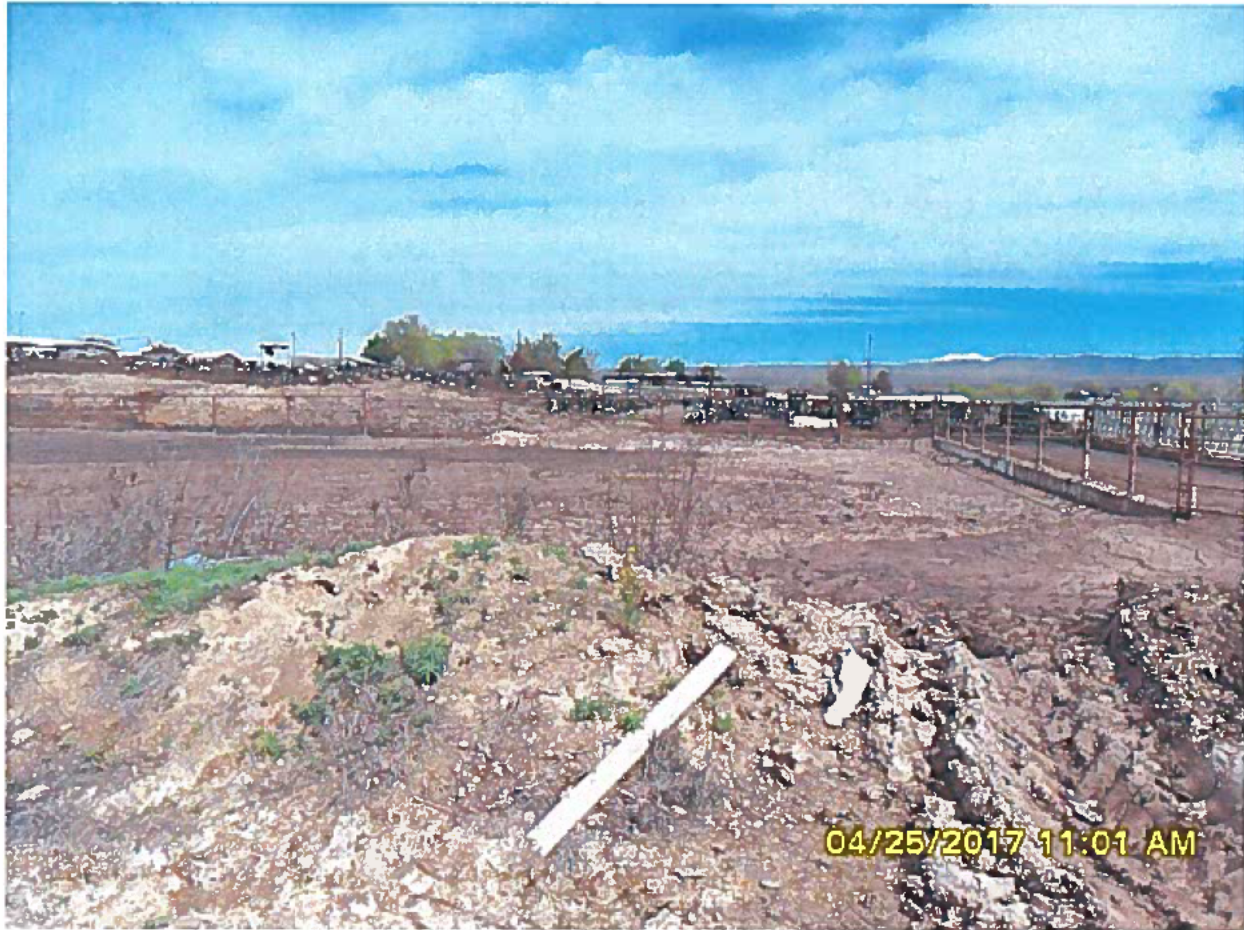
Photo #3: Northerly view of one of the scrape pits in the foreground. This is one of two scrape pits at the facility. Manure from the area of the feed bunkers is scraped and routed into a scrape pit. Manure from the feed bunker on the east side of the facility is scraped into this scrape pit. Manure in the scrape pits are allowed to dry and then hauled offsite for land application. Camera photograph #SAM 2736.

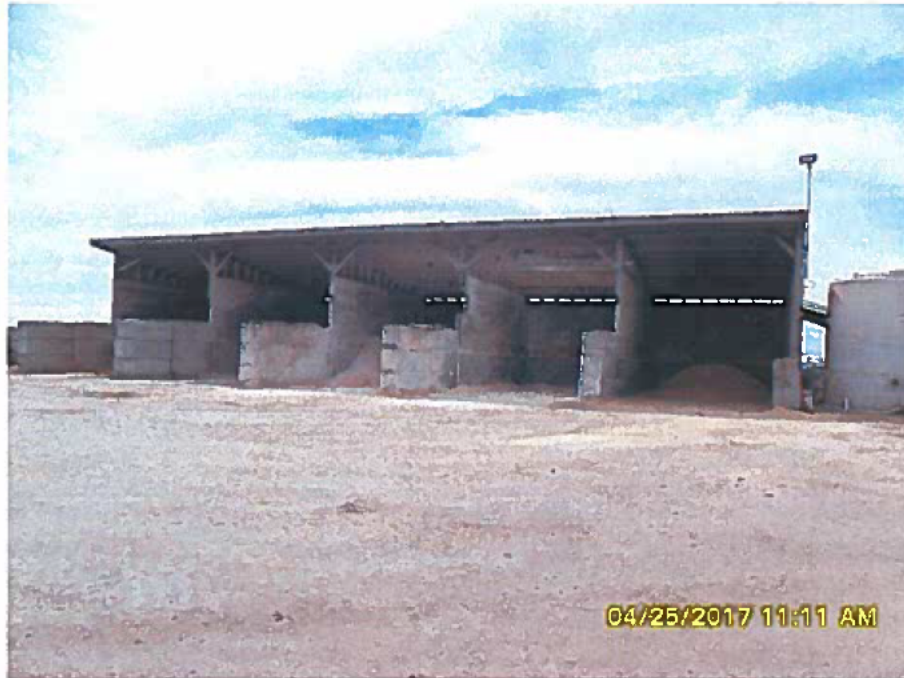
Photo #6: Southerly view showing the commodity shed at the facility. Camera photograph #SAM 2739.

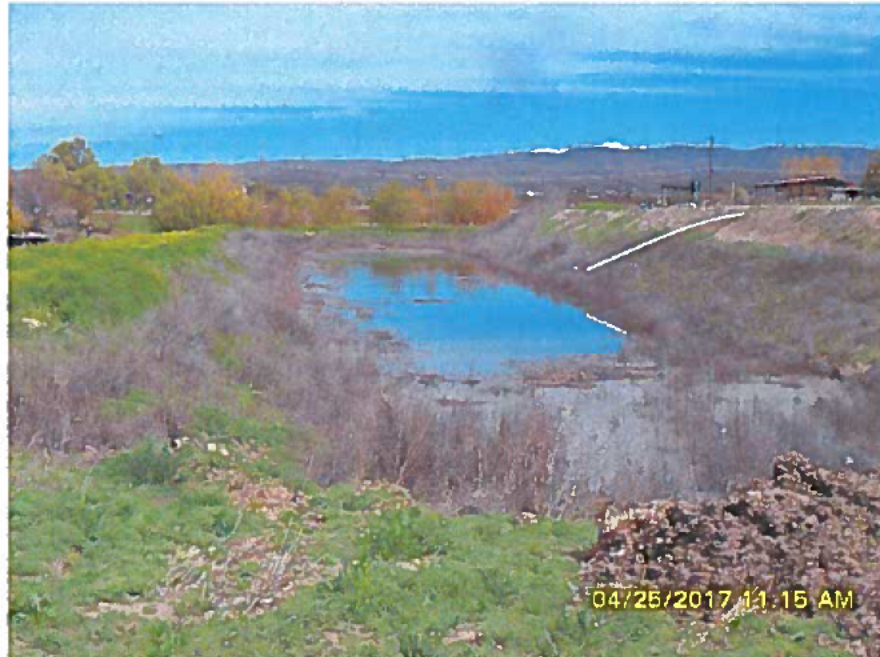
Photo #7: Northerly view of the rectangular catch basin located along the west side of the facility. Note the white pipe which is an overflow from the storage pond system. This catch basin can hold up to 478,000 gallons. Water in this catch basin is ultimately pumped into storage pond #1. Camera photograph #SAM 2740.

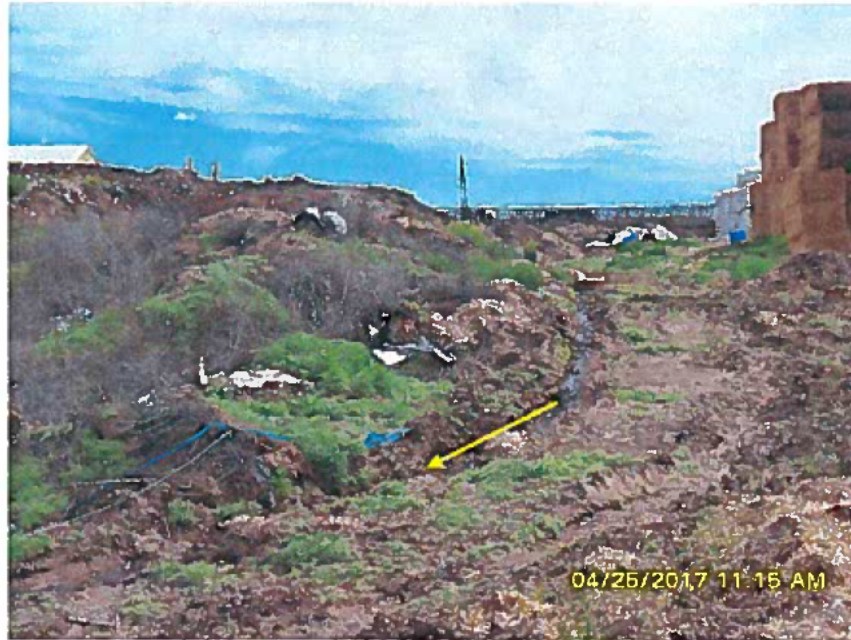
Photo #8: Easterly view showing drainage that enters the catch basin shown in the previous photograph. This drainage enters the south side of this catch basin which is located to the left of the photograph. Camera photograph #SAM 2741.

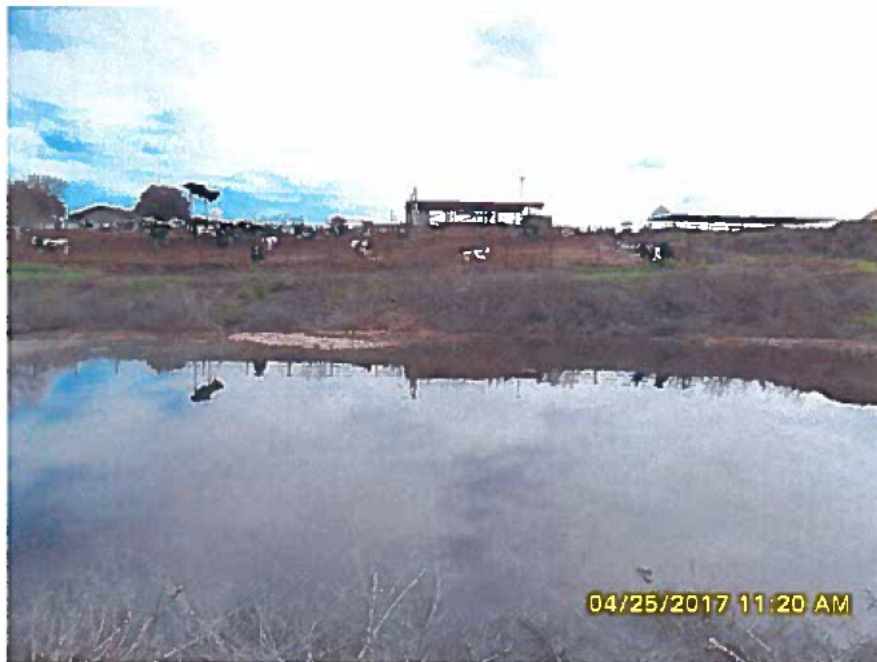
Photo #9: Easterly view of a catch basin located along the west side of the facility. This catch basin is located just north of the rectangular catch basin shown in photograph 7 above. Drainage from the heifer pens shown in the background overflows and drains into this catch basin. Water in this catch basin is ultimately pumped into storage pond #1. Camera photograph #SAM 2742.

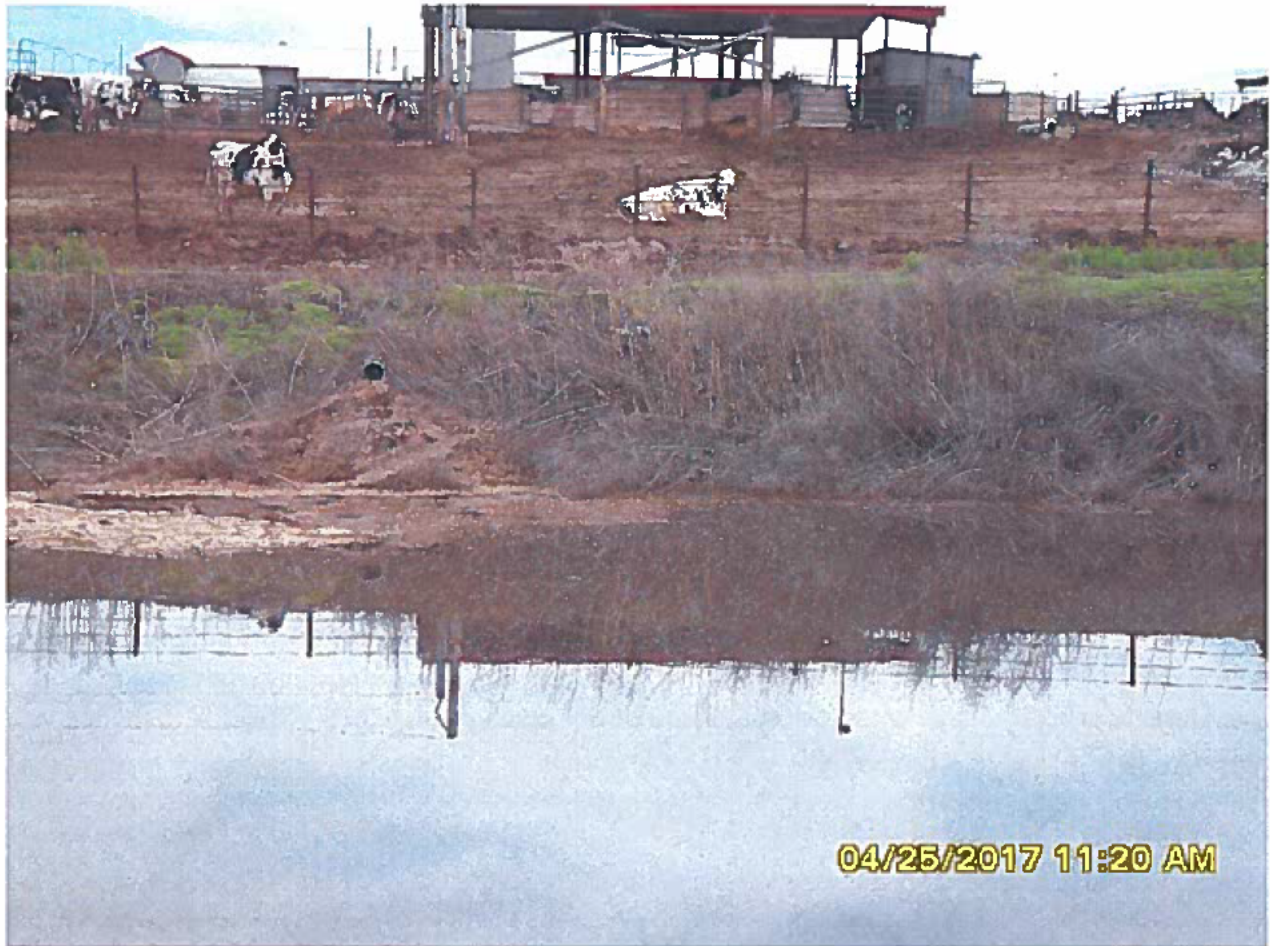
Photo #10: Easterly view showing a close-up of the catch basin shown in the previous photograph. Camera photograph #SAM 2743.

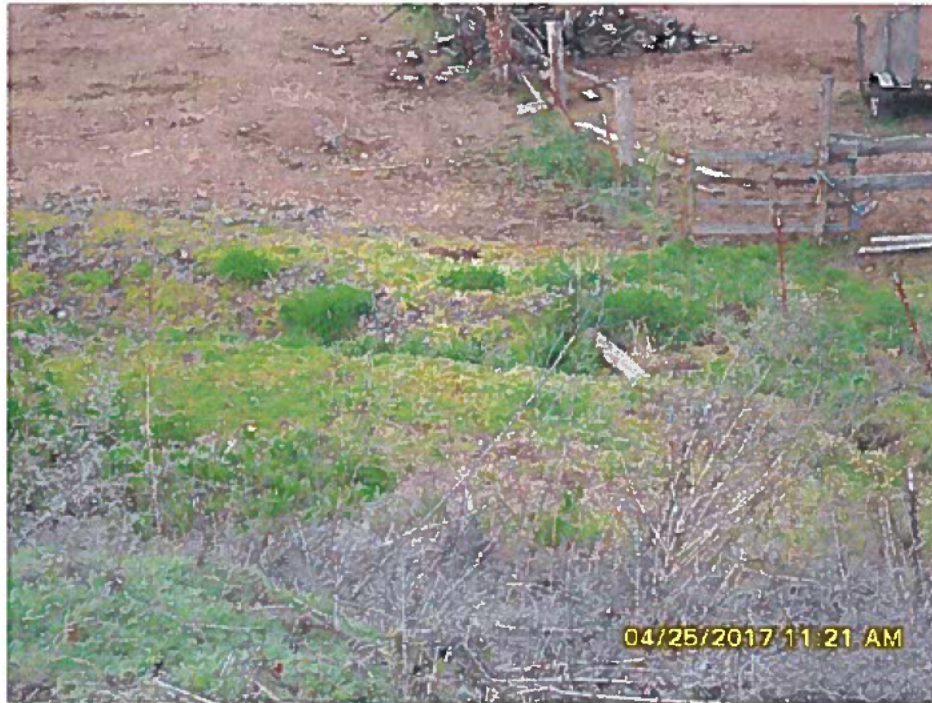
Photo #11: Westerly view of a ditch located just west of the catch basin shown in the previous photograph. Camera photograph #SAM 2744.

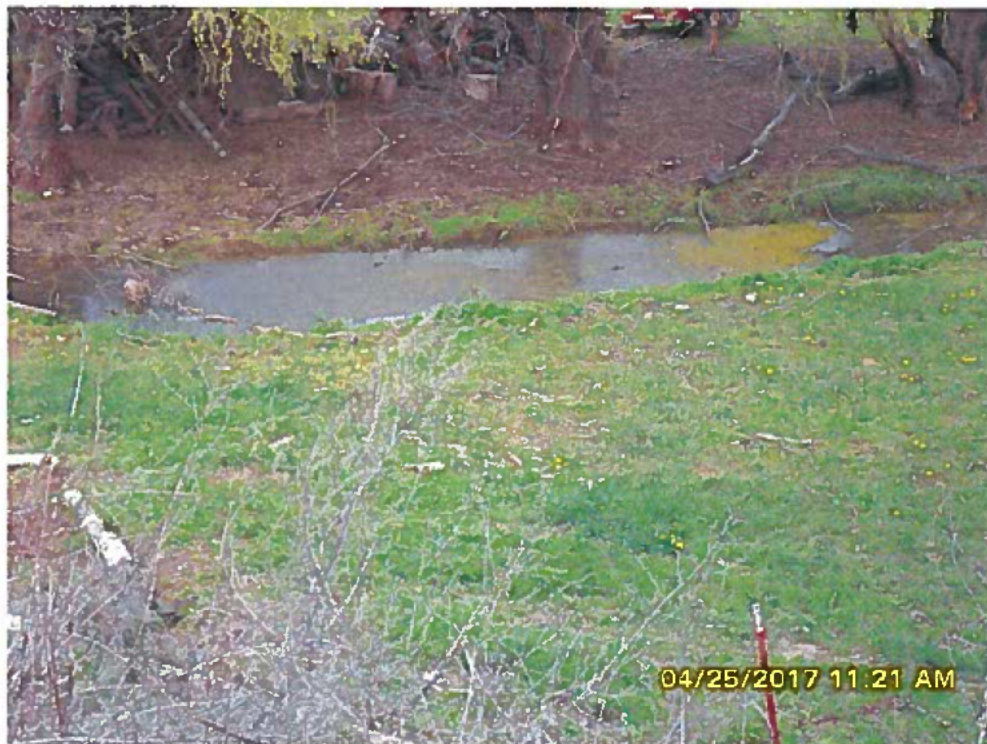
Photo #12: Westerly view of a ditch located just west of the catch basin shown in photograph #10. Camera photograph #SAM 2745.

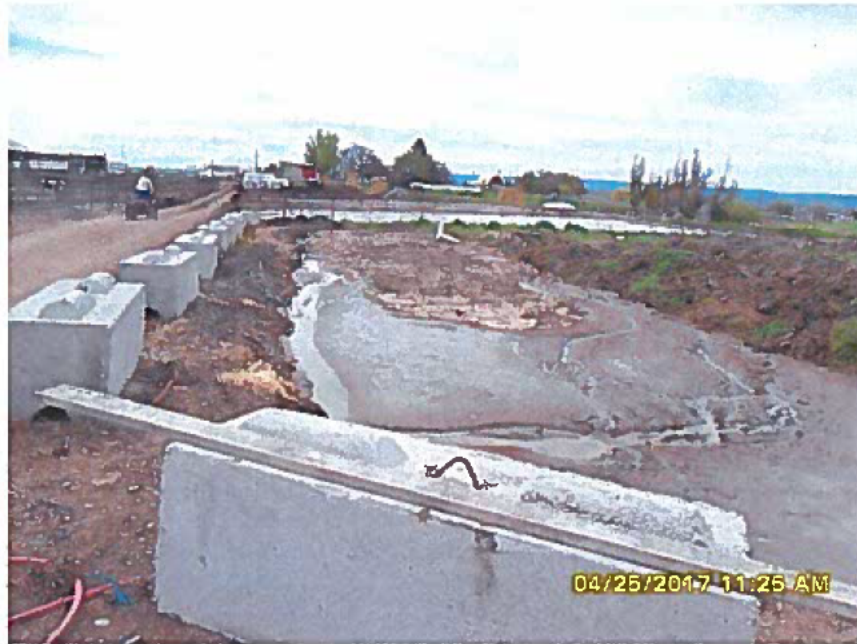
Photo #13: Southerly view showing one of three settling ponds (foreground) which receive wastewater from the confinement area. Solids collect in this settling pond. Liquids proceed to storage pond #1 (background) and then to storage pond #2 for long term storage. Camera photograph #SAM 2746.

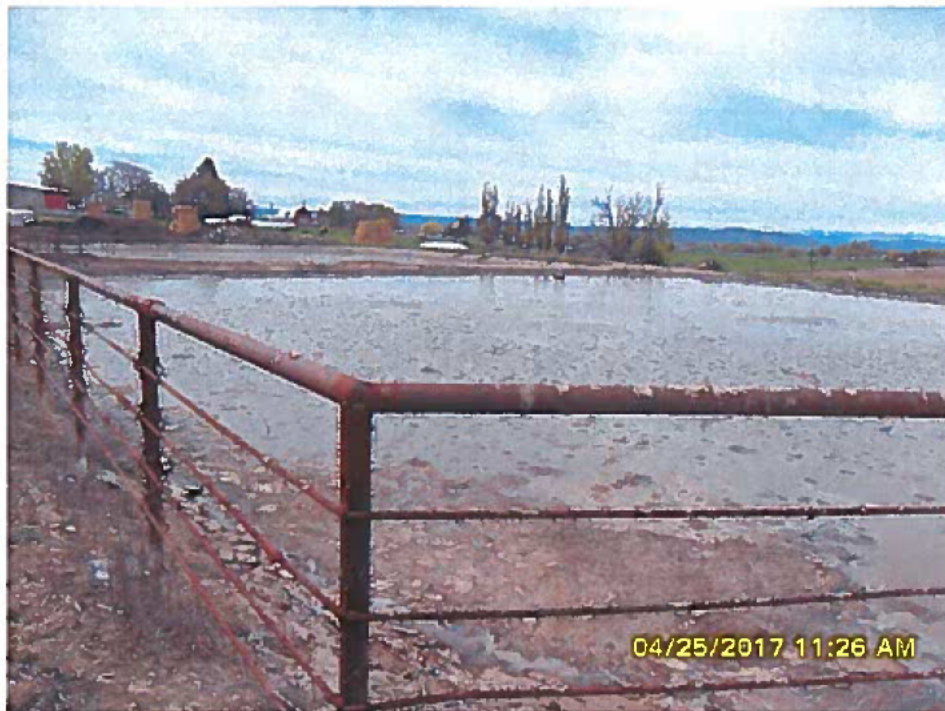
Photo #14: Southerly view showing storage pond #1 in the foreground and storage pond #2 in the background. Camera photograph #SAM 2747.

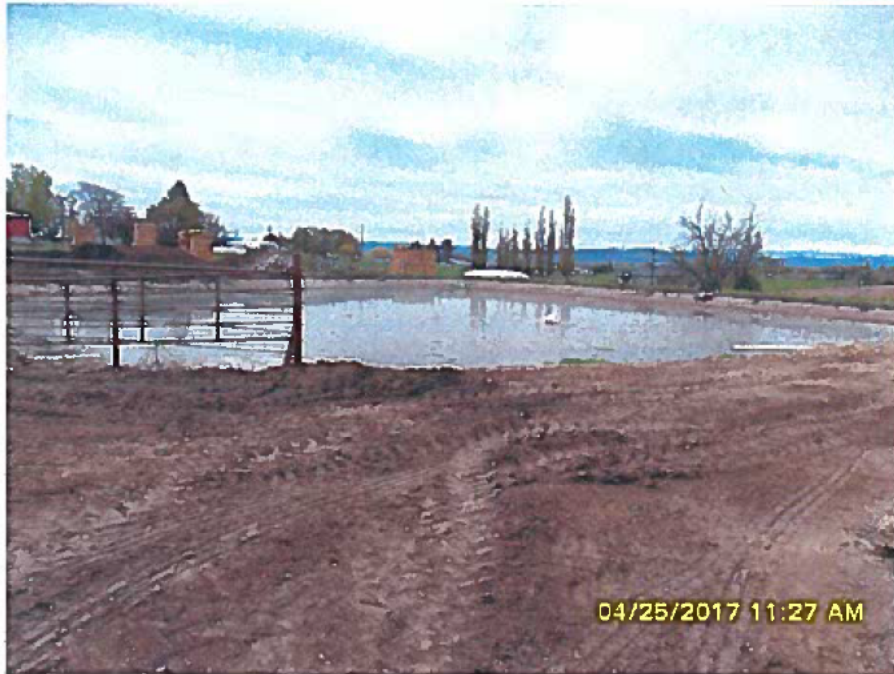
Photo #15: Southerly view showing storage pond #2. Camera photograph #SAM 2748.

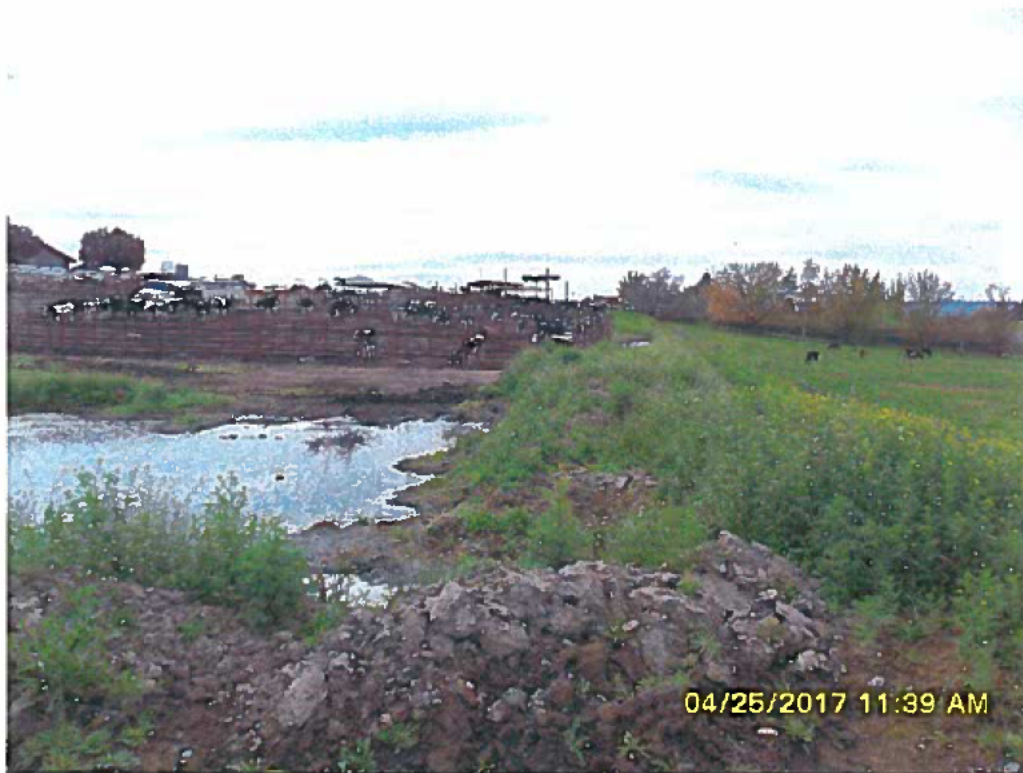
- A. **Wastewater In Close Proximity to Drainage Ditch** At the time of the inspection, I inspected the areas along the west side of the heifer confinement lot located near the northwest corner of the facility. In general, this heifer lot slopes down gradient to the west in the direction of a drainage ditch located just west of the facility boundary.

Photo #16: Southerly view showing a catch basin located just north of a heifer confinement area. The topography in this area slopes down gradient to the right. A drainage ditch is situated to the right of the photograph. Camera photograph #SAM 2749.

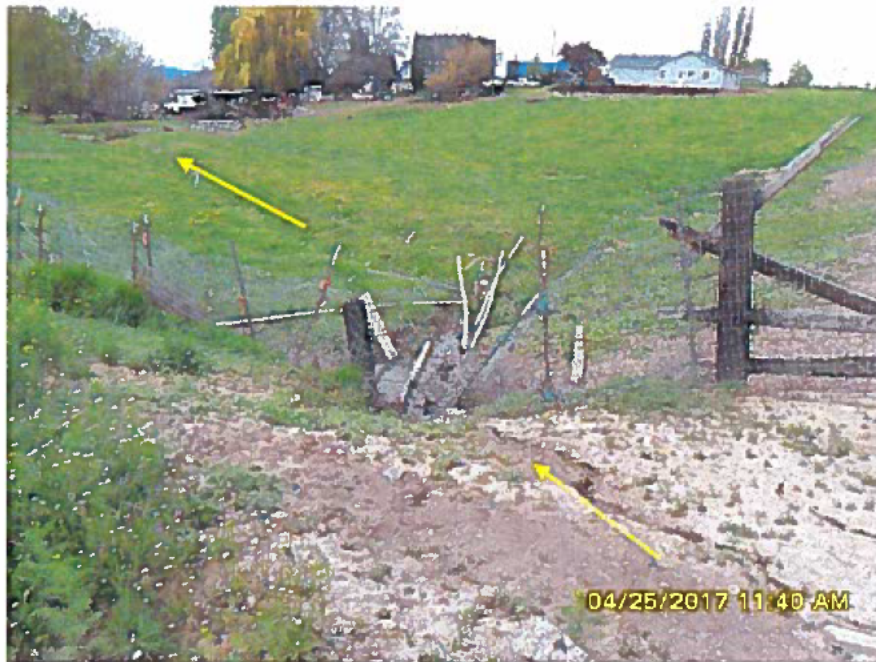
Photo #17: Southwesterly view showing a drainage ditch located near the northwest corner of the of the property. Camera photograph #SAM 2750.

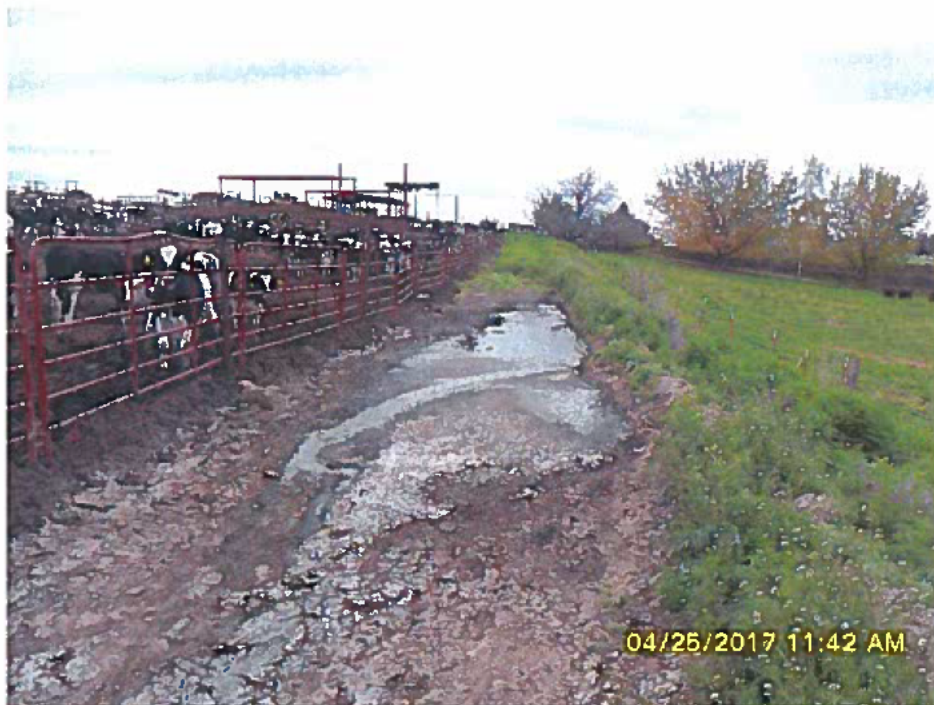
Although runoff from the heifer confinement pen does not appear to have reached the drainage ditch at the time of the inspection, the concern is that during heavy rainfall events runoff from the heifer pen could reach the ditch. See photograph #s 16 to 18 of Attachment A for a view of the heifer pen, the drainage ditch and the wastewater pooled just west of the heifer confinement pen.

Photo #18: Southerly view showing the west side of the heifer confinement area. Note the accumulated water on the bank down gradient of the heifer confinement area. The drainage ditch in the previous photograph flows to the right of this photograph. Camera photograph #SAM 2751.
